**HOWARD COUNTY
WATERSHED STEWARDS ACADEMY (WSA)
HOME OWNER ASSOCIATION (HOA)
PARTNERSHIP PROGRAM**

Overview of Study Design, Parameters Sampled and Locations

2016 Stream Monitoring Roundtable February 19, 2016

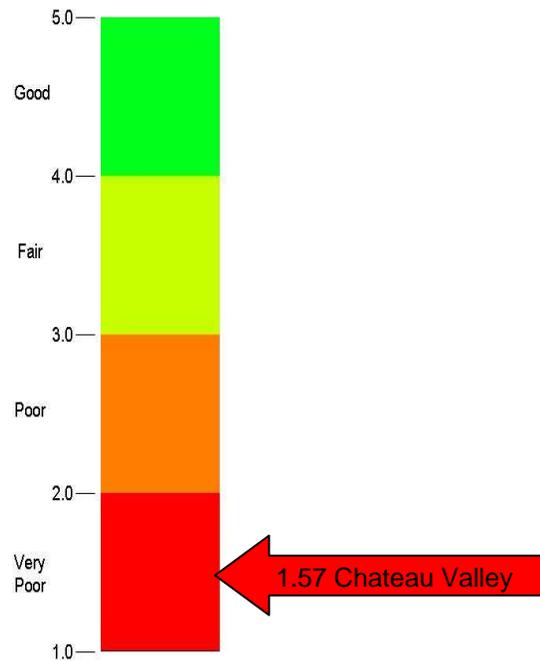
Stream Waders Index of Biotic Integrity Scale

Index of Biotic Integrity Score: **1.571429**

Overall biological condition of this site is: **VERY POOR**

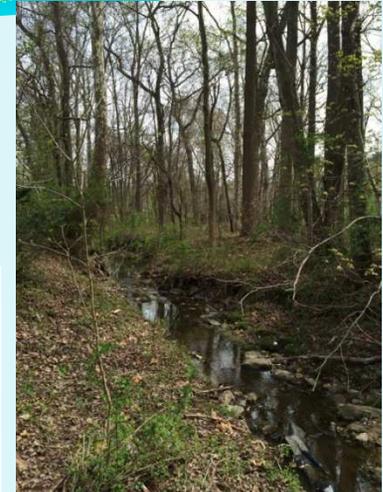
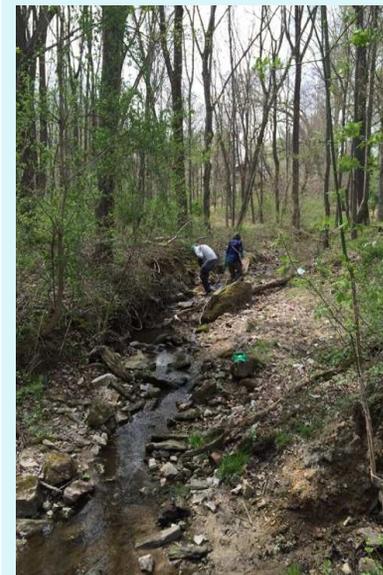
Stream Characteristics (From Howard County Stream Mapper)

Report details	
Author	Lori L.
Date	April 19, 2015
Observations	
Nearby Land Use	residential
Streamside Plants	mostly trees
Bank Cover	mostly trees
Bank Height	2 feet
Stream Width	8 feet
Left Bank Shape	sloped
Right Bank Shape	sloped
Invasive Plants	yes - vines
Blockages	none
Sedimentation	rocks half covered in mud
Trash	light trash
Exposed Utilities	none
Notes	
Lots of filamentous algae, from neighborhood fertilizer most likely Springs Stream Wader site
